Juvenile Hall/Camp Singer Camera Installation

Addendum #2

Date Issued 6/27/2018

Yuba County – Juvenile Hall Camera Cabling, etc.

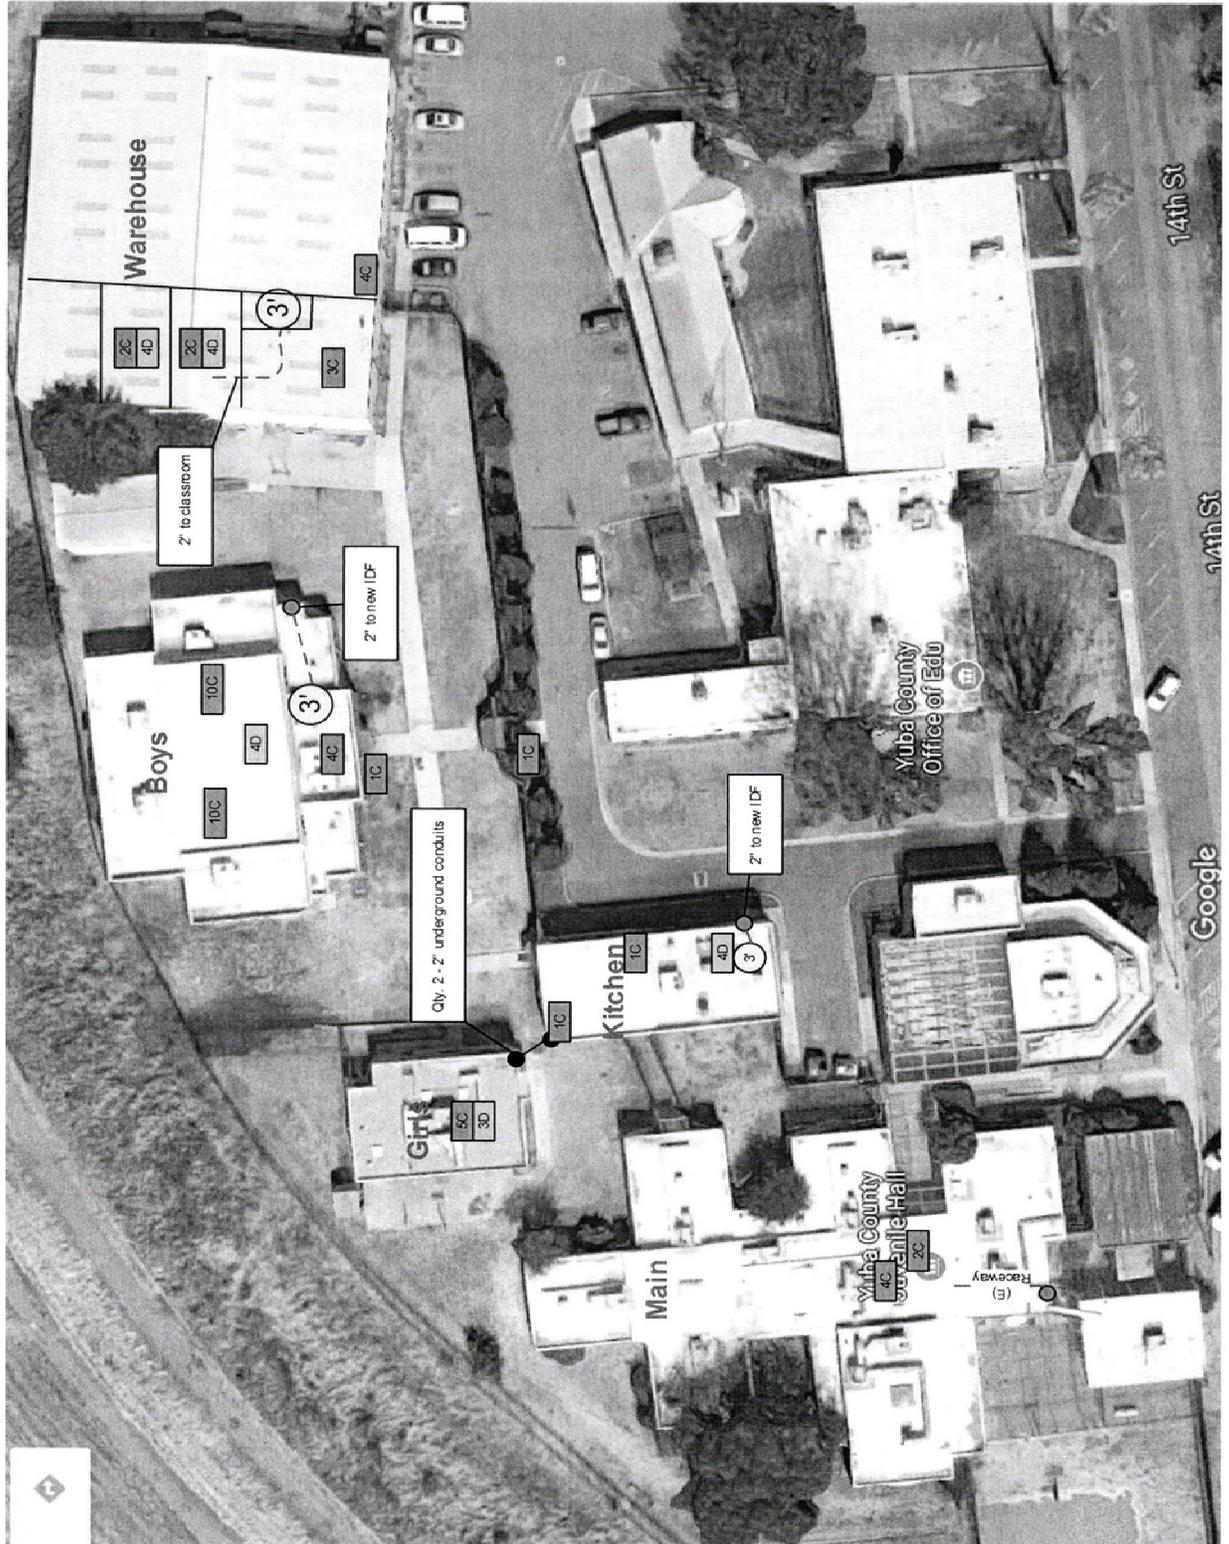
- ③ New 3' IDF Cabinet (with new Power Circuit)
- New 2" Conduit
- (exist.) Fiber
- (new) Aerial
- Camera (Cat 6)
- Data (Cat 6)
